An Analysis of Hull Structure Plating Failures Due to Corrosion

Špiro Ivošević^a, Nataša Kovač^b

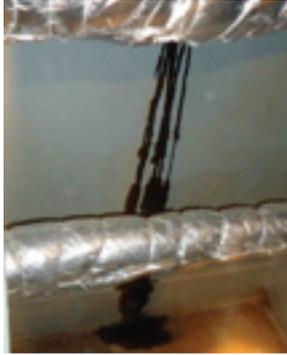
Severe damage can cause the total loss of ships or environmental pollution. Given that pollution caused by fuel leakage through ship plating (Figure 1) is manageable compared to more extensive damage resulting in excessive pollution, research on fuel tanks is of utmost importance (Ivošević et al., 2017; Ivošević et al., 2019; Ivošević et al., 2020.a).

Figure 1.
Fuel oil tank leakage.

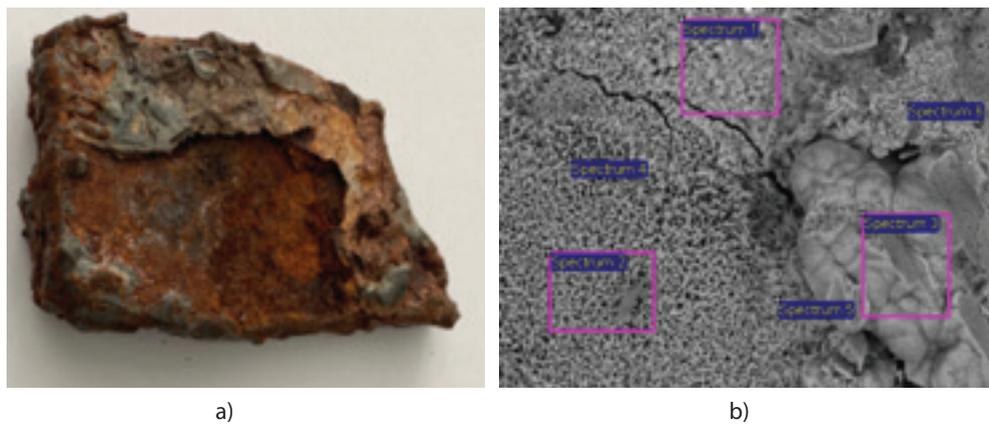
Figure 3.
Steel sample and corresponding EDX sample: a) sample from the bottom of the steel plate, b) a photo of the scanned sample from the bottom.

samples I11 and I12 faced the cargo hold (the top of the plate), while sample I21 faced the fuel tank (the bottom of the plate). The chemical composition of each plate was determined by means of Energy Dispersive X-ray analysis, where each sample was subjected to 6 spectrums under the magnification of 70, 100 and 200. Mean value, standard deviation, maximum and minimum values were calculated for each sample and each element - O, Cl, Fe and etc. The corresponding results of chemical composition analysis of all samples were covered by previous analysis (Ivošević et al., 2022).

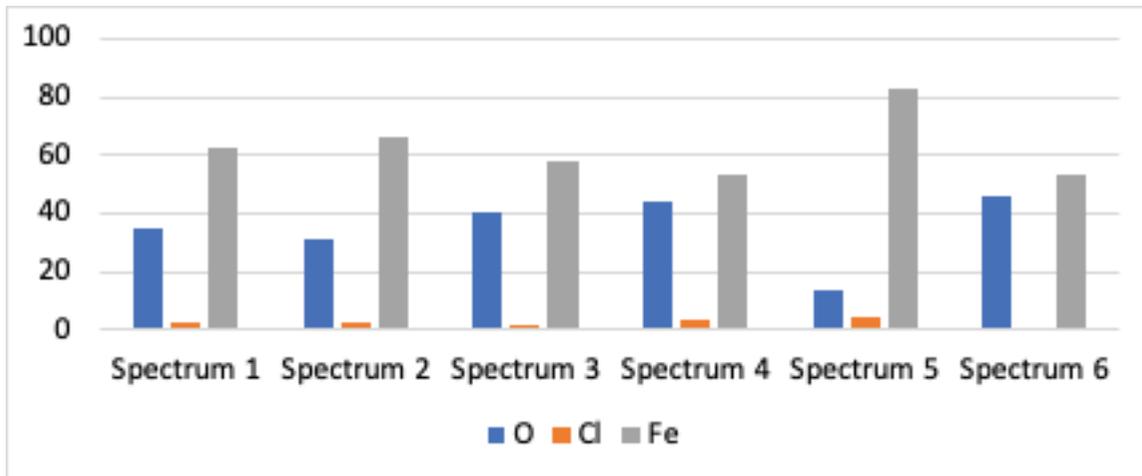
Data presented in Figure 6 (the EDX results) clearly show that after extended exposure to corrosion, the side of the analyzed fuel tank steel plate facing the cargo hold (IBP 1.1 and IBP 1.2) has considerably different chemical composition than the side facing the fuel tank (IBP 2.1). Namely, the EDX analysis detected the presence of only iron, oxygen and a small amount

Figure 6. Chemical composition of IBP 1.1 and Sample 1 (corroded steel plate facing the cargo holds).

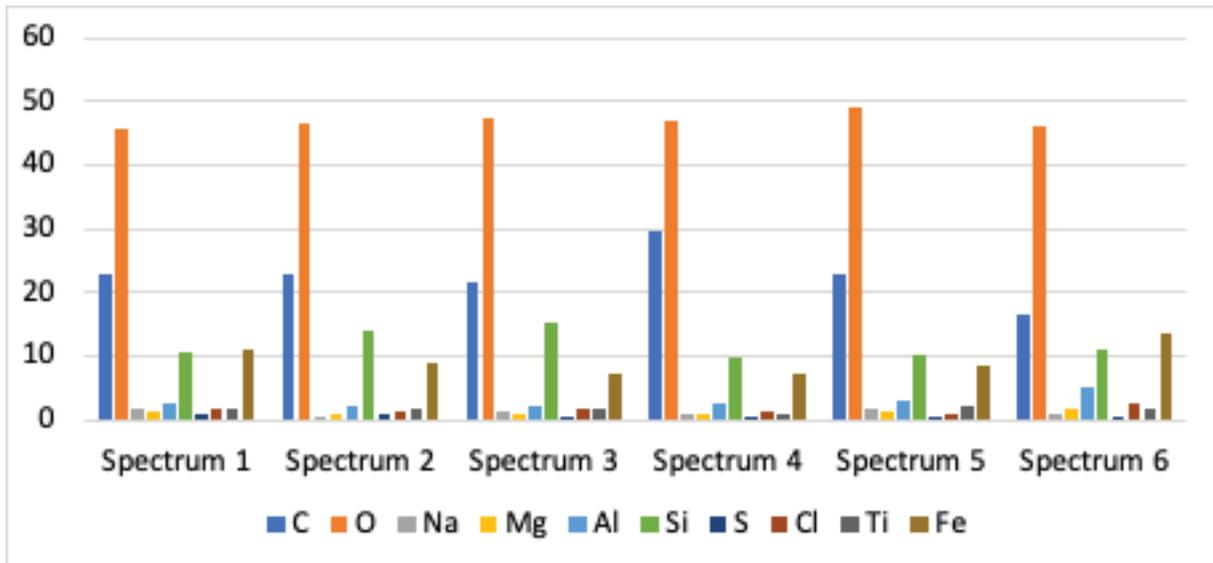
of chloride ions on the steel plate of the inner bottom plating facing the cargo hold. By contrast, in addition to iron, oxygen and chloride ions, the analysis detected inorganic ions (Mg, Na, K, Al and Si) and organic components (carbon, sulfur) on the surface facing the fuel tank. While inorganic ions could be due to seawater exposure, organic components are considered to be the residues of fuel transported in the tank. All results presented in Figures 6 and 7 and Tables 2 and 3 are expressed in weight %.

Figure 7. Chemical composition of IBP 2.1 and Sample 1 (corroded steel plate facing the fuel tank).
