An Analysis of Hull Structure Plating Failures Due to Corrosion

Špiro Ivošević^a, Nataša Kovač^b

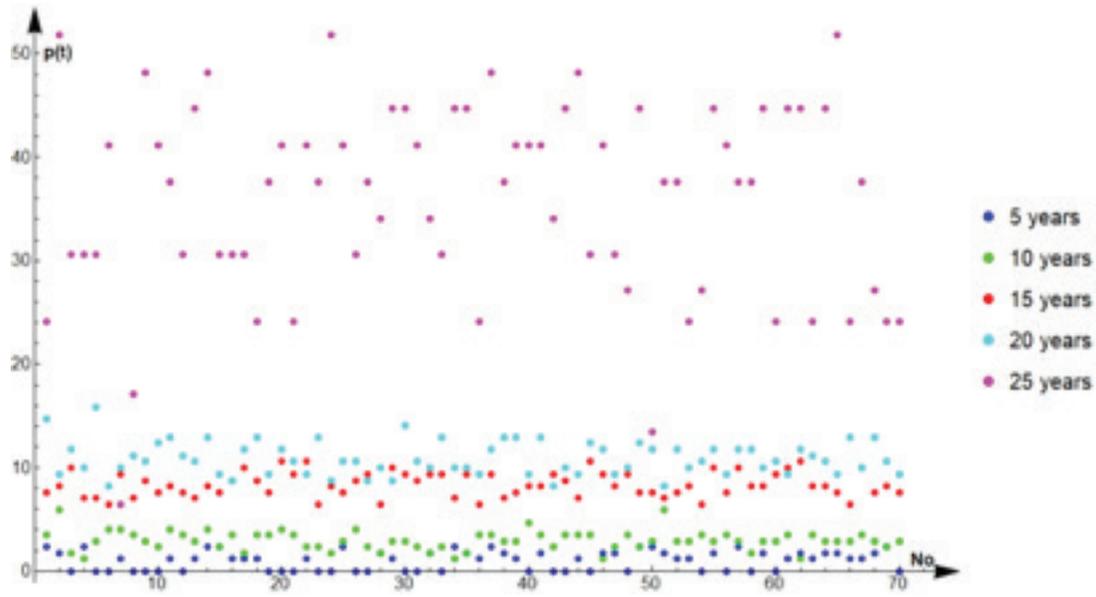
Figure 2.
The empirical database on the percentage of corrosive wear and tear of the inner bottom plate structure.

years, there were 5 different groups of empirical data which were subjected to further statistical analysis. Each group of data was assigned a different color in Figure 2. Furthermore, Figure 2 shows the ordinal numbers of corrosive wear measurements on the x-axis, while the corresponding percentage of the corrosive wear of the inner bottom structural plating is shown on the y-axis.

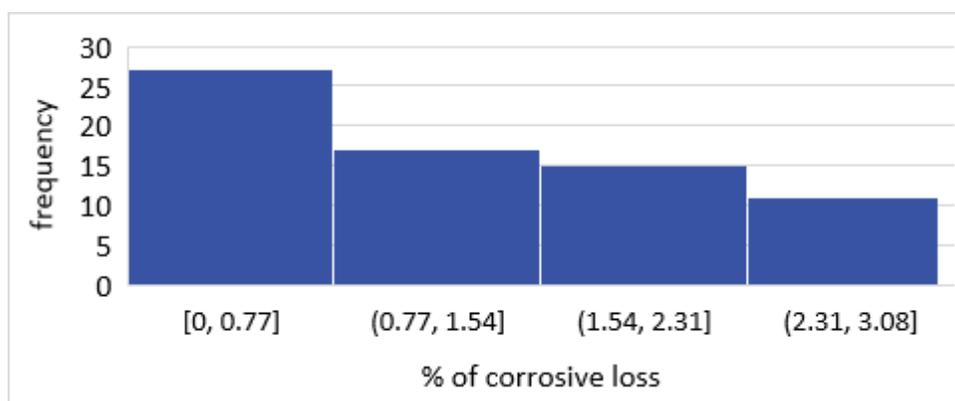
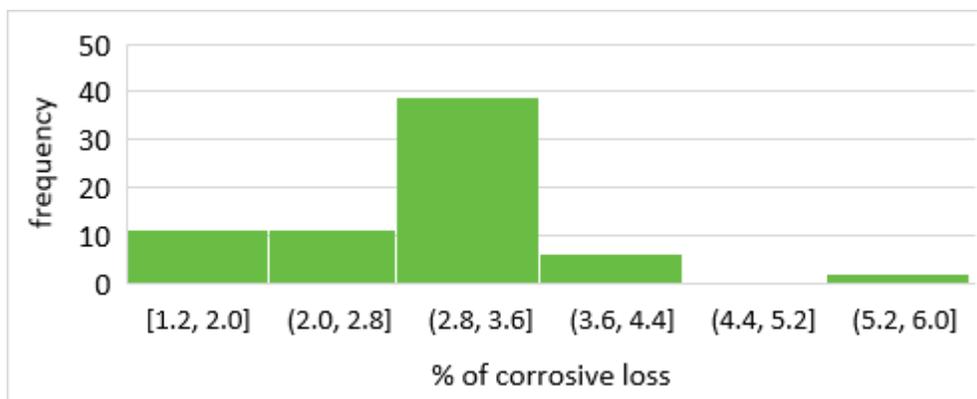
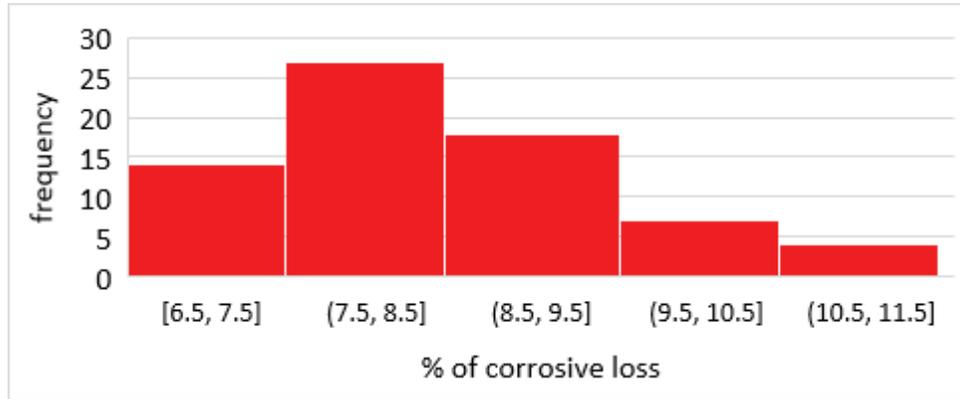
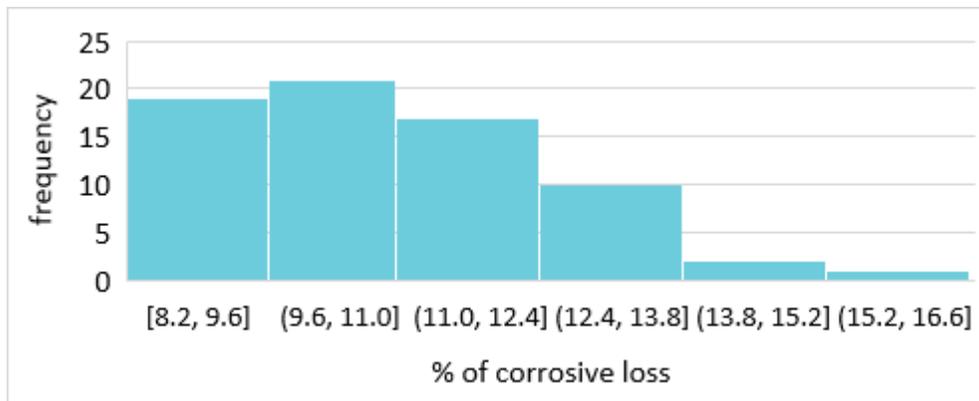
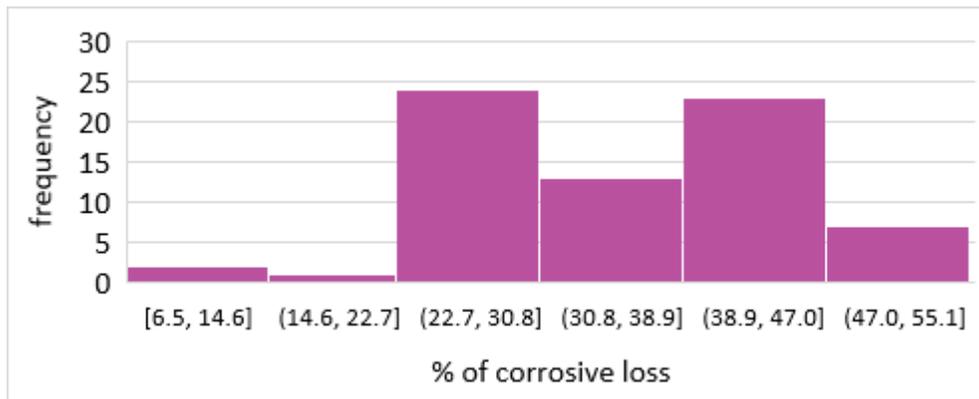
Figure 4 shows empirical data in the form of a histogram. There is one graphic representation for each observed interval of ship exploitation. The x-axis of these graphs shows the wear percentage intervals of the original steel plates caused by the influence of corrosive processes. The y-axis shows the number of measurements whose values correspond to the defined wear percentage intervals.

Figure 4. Histograms of corrosive wear percentage grouped by the length of ship exploitation.

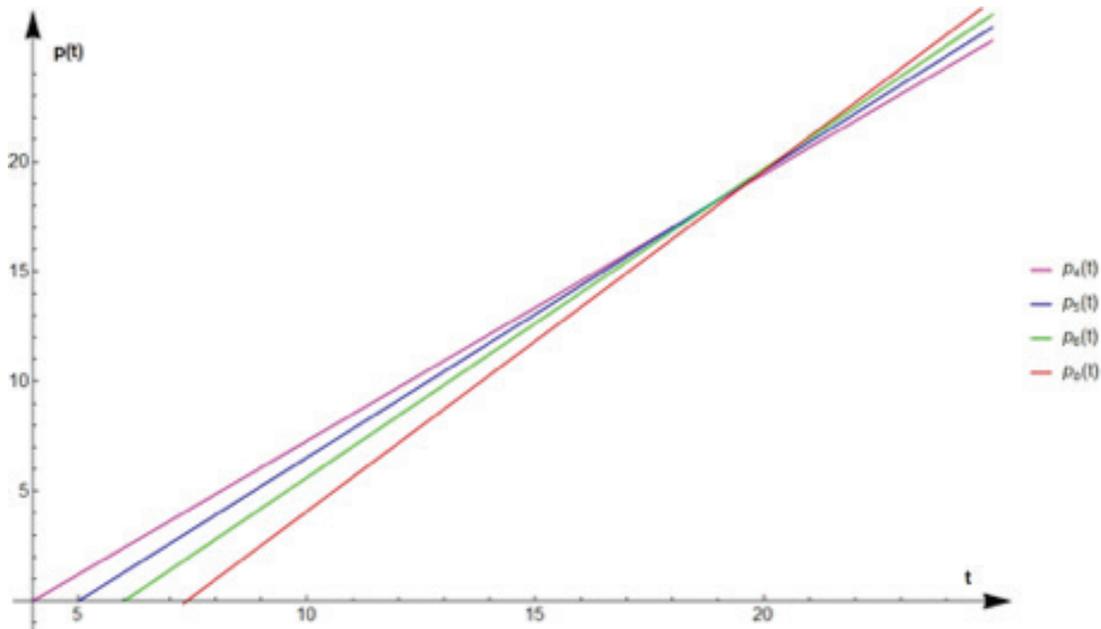
Models represented by expressions (4) - (6), i.e. $p_4(t)$, $p_5(t)$, and $p_6(t)$ models were obtained by using T_{cl} values 4, 5, and 6, respectively, along with the previously defined assumption: $c_2=1$. The best-fitted model was labeled as $p_b(t)$ and is represented by formula (7). This model indicates that the most suitable T_{cl} value is 7.4 years.

The four linear models are graphically presented in Figure 5. The linear model that most adequately follows the empirical data of the corrosive wear percentage of the inner bottom plating structures is characterized by a slightly higher value of the p_0 parameter - $p_0=1.55146$ %/year.

Figure 5. Graphical representation of linear models of IBP structure wear percentage.
